Evaluation of corrosion level of naturally corroded bars using different cleaning methods, computed tomography, and 3D optical scanning

Fernandez, I., Lundgren, K., Zandi, K. (2018). Evaluation of corrosion level of naturally corroded bars using different cleaning methods, computed tomography, and 3D optical scanning. *Materials and Structures/Materiaux et Constructions*, 51(3). <http://dx.doi.org/10.1617/s11527-018-1206-z>

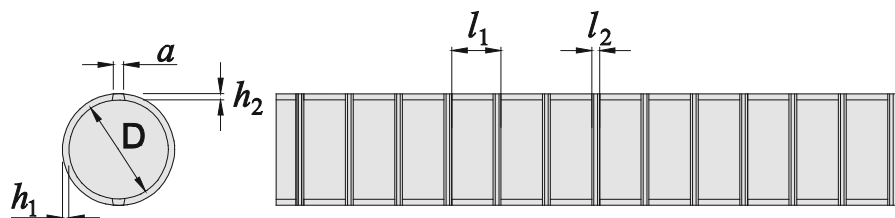
**Fig. 1** Geometry of ribbed reinforcement bars

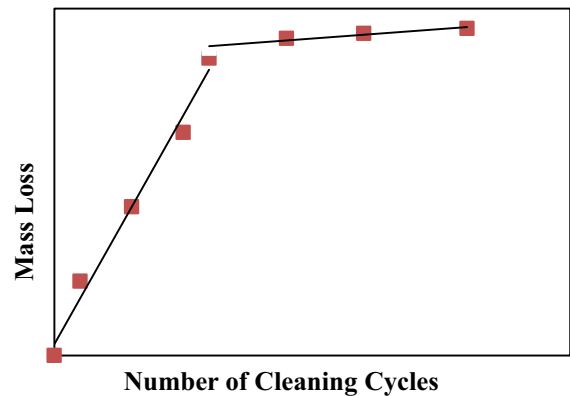
**Fig. 2** Standard recommendations for cleaning corroded steel bars [20]

supply, and the engine was in charge of continuously rotating the brush at the same speed. The recommendation [20] did not specify any cycle or exposition time, and thus each cycle was not systematically measured. Instead, each cycle was distinguished when perceptible changes on the surface due to the rust removing were observed after the bar was swept from end to end. According to this criterion, the necessary time for each cycle was approximately in the range of 10 min to 15 min based on the actual level of corrosion.

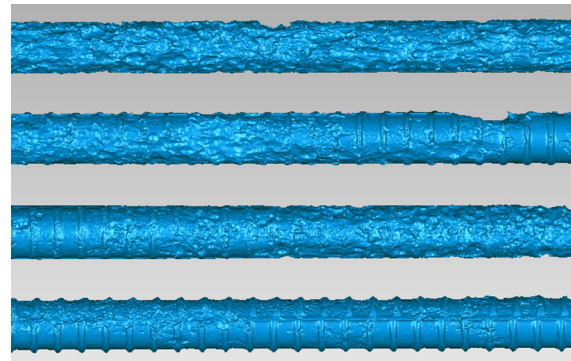
The outcome of the optical measurement corresponded to a very fine mesh of triangular surface polygons connected by nodes, see Fig. 3. The average size of the element corresponded to 0.014 mm^2 with a side length of approximately 0.15 mm. The number of triangular elements in each scanning was between 2,000,000 elements and 3,000,000 elements depending on the corrosion level. A global coordinate system,

Fig. 3 3D surface generated from the 3D scanning

(X, Y, Z), was established and referenced to the end of the bar. The high resolution of the surface mesh allowed for a sufficiently detailed description of the geometry of the bar to obtain information on features including pit depth and length, pit distribution, and loss of cross-sectional area along the bar length.

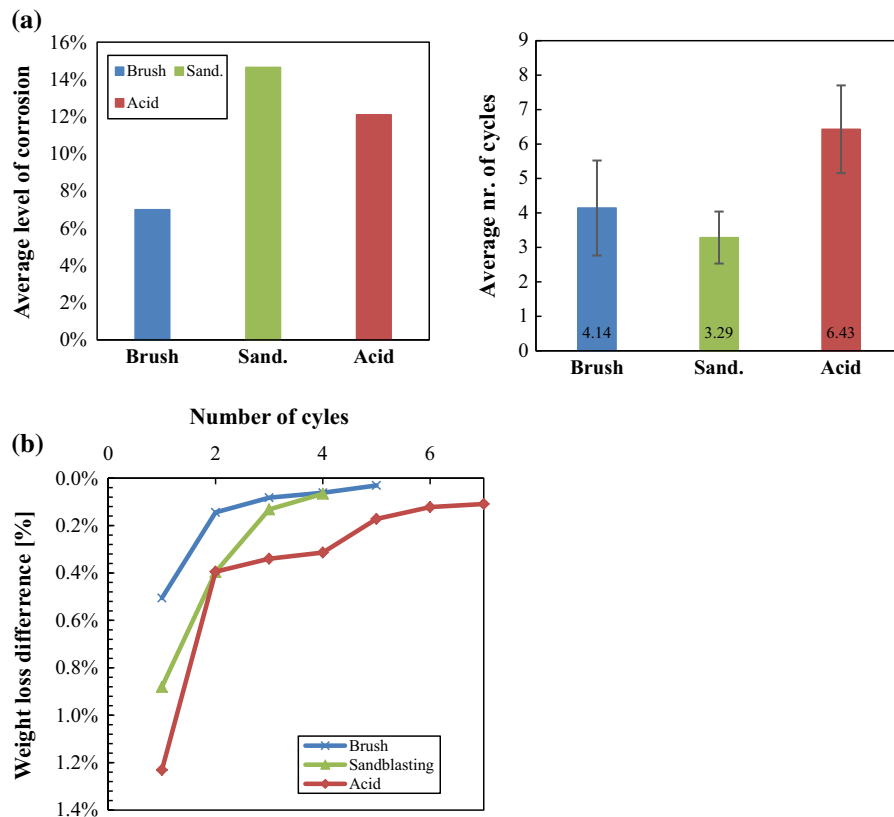
Figure 4a shows the average mass loss of all bars cleaned with each cleaning method. The same proposed methodology [20] was followed for each cleaning method with reiterated cleaning cycles until the mass loss was lower than 0.2% of the last measured weight. However, large differences were observed in the final measurements between the three selected options as shown in Fig. 4a. The sandblasted specimens exhibited the largest measured corrosion level, systematically both for all the specimens, and for the average level of corrosion in each group. This was followed by the acid cleaned specimens. Finally, the mechanically brushed specimens exhibited the smallest measured corrosion level. The methods were expected to result in similar levels of the average mass loss, since the bars were randomly obtained from the tested beams, from areas which had been exposed to similar aggressive environment and subjected to similar damage (all the specimens presented clear signs of deterioration). Thus, the fore-mentioned discrepancies indicate that the proposed recommendations did not provide information to a user with respect to the degree of cleanness of the bar at the end of the process, as opposed to whether the performed cleaning method reached its maximum cleaning capacity for a set of specific conditions including steel type, initial amount of mortar, and corrosion products attached or cleaning agent (such as chemical, or brush). This assertion is backed by Fig. 4b, in which the average number of cycles applied to each specimen to reach the necking point together with its standard deviation is shown. It was observed that the number of cycles remained constant regardless the final level of corrosion.

As shown in Fig. 4b, the number of cycles necessary to obtain a weight loss difference lower than 0.2% within cycles (which was defined by the authors as a reference value based on the degree of harshness of the cleaning methods) ranged between 4 cycles and 7

Fig. 4 **a** Average mass loss for the different cleaning methods. **b** Examples of cleaning cycles for each cleaning method

cycles according to the method for representative specimens. Sandblasting reached its highest cleaning capacity in fewest number of cycles whereas acid immersion needed the highest number of cycles to reach the defined threshold. The cleaning speed of the metallic brush method ranged in between that of sandblasting and acid immersion on an average, although the scatter observed among the different bars increased in contrast to those observed in the other methods. This scatter could indicate higher dependence of the brush cleaning method on the actual corrosion level than the others.

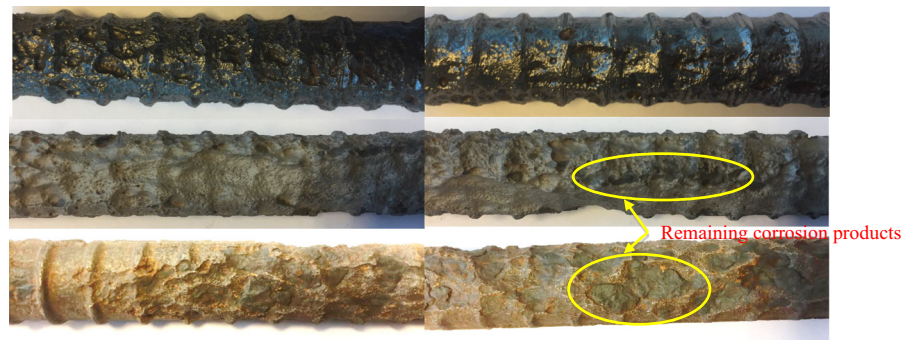
Important differences were observed in the final shape of the surface after cleaning. The finishes for the different methods corresponded to shiny and smooth

Fig. 5 Cleaned bars. From top to bottom, the figure shows metallic brush, sandblasting, and acid immersion

for metallic brush, matt and granulated for sandblasting, and dark brown for acid cleaning. All the methods showed corrosion pits along the bar irrespective of the finish for each method. However, the depiction of pits was significantly more clear after sandblasting when compared to the other methods, as shown in Figs. 5 and 6. Subsequently, a more comprehensive impact of the corrosion on the bar surface was observed in which larger and deeper pits were found in the sandblasted bars as shown in Fig. 6. This was not obtained when the bars were extracted or when the bars were cleaned with the two other methods.

bar were only unveiled after a significant period of time elapsed as shown in Fig. 5. This was potentially due to the drying out of the acid solution and the occurrence of slight corrosion in the sound steel that changed the surface shade.

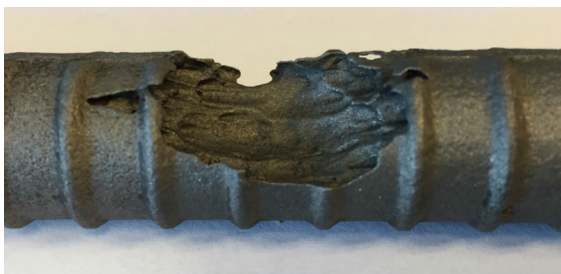
Fig. 6 Pits unveiled after sandblasting

Conversely, sandblasted specimens always exhibited remaining rust clusters that were distributed along the bar during the cleaning cycles. Specifically, the mentioned clusters were also used as additional visual criteria to define the exposition time in each cycle. Nevertheless, there was a significantly lower presence of rust clusters at the necking point in the case for sandblasting when compared with acid cleaning as clearly shown in Fig. 5. The remaining corrosion products on the bar surface were a result of the compromise between the corrosion products and sound steel removed in each cycle, which must always be lower than the method harshness. Corrosion products, in addition to sound steel must be removed in the cycle in order to maintain the accuracy of the measured level of corrosion.

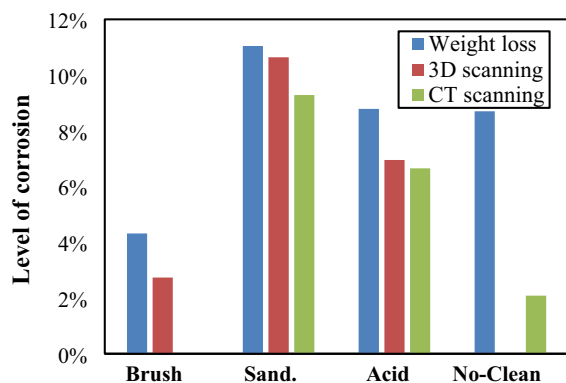
Figure 7 shows an overall description of the obtained results by means of depicting the average measurements. As shown in the figure, 3D scanning

Fig. 7 Average corrosion level for each presented method

measurement. Average 3D scanning and weight loss values described very good agreement with respect to sandblasting cleaning method, and the difference

between the average weight loss and that in CT scanning was higher for all the cleaning methods.

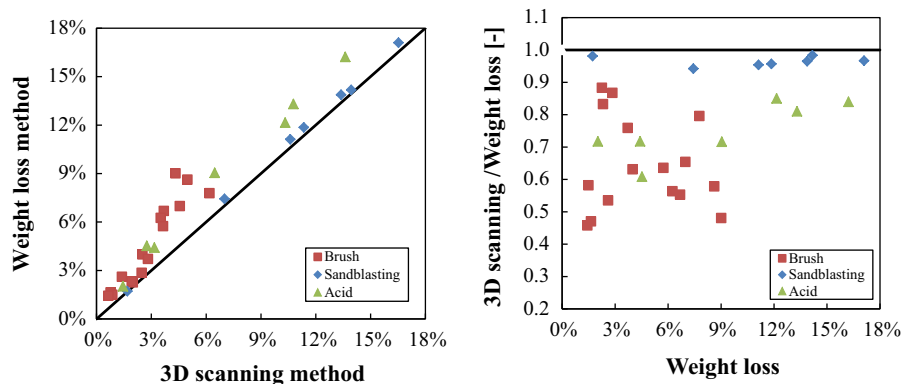
A direct comparison between single weight loss and 3D scanning corrosion levels for the three proposed cleaning methods is shown in Fig. 8a. As shown, gravimetric weight loss typically resulted in higher corrosion levels when compared with those from 3D scanning measurements irrespective of the utilised cleaning method. However, the results indicated better agreement between the weight loss and those of 3D scanning for the sandblasted bars wherein there was a minor difference between both methods. In contrast, both acid and metallic bristle brush exhibited higher deviations when compared to sandblasting. Metallic brush cleaning exhibited the maximum difference, and the obtained values followed a trend in which a higher corrosion level led to a higher discrepancy between both measurements. Additionally, the highest corrosion level measured using both weight loss and 3D scanning was observed for the sandblasted specimens, and this was followed by the acid and the metallic

Generally, sandblasting cleaning yielded the best agreement irrespective of the actual corrosion level as shown in Fig. 8b by the ratio of 3D scanning to weight loss measurement. Acid cleaning exhibited a slightly better agreement when the corrosion level increased, and this indicated that the accuracy of the cleaning method was less relevant for increases in the corrosion level. Conversely, metallic brush cleaning displayed large scatter and a clear trend was not observed.

Fig. 8 Comparison of 3D scanning versus weight loss measurements for different cleaning methods

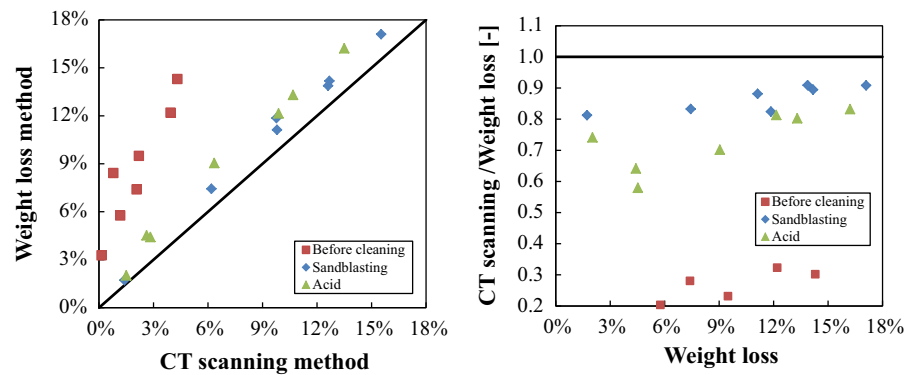
The same comparison for the CT scanning technique is presented in Fig. 9. The CT scanning measurements resulted in smaller corrosion levels when compared with the weight loss measurements. The same behaviour was observed for all the cleaning methods as well as for the bars scanned prior to cleaning. In a manner, similar to the 3D scanning results, the best agreement between CT scanning and weight measurements was exhibited by the sandblasted specimens while the bars scanned prior to cleaning showed the maximum disagreement.

Fig. 9 Comparison of CT scanning versus weight loss measurement for different cleaning methods and prior to cleaning

On average, corrosion levels measured for the bars that were cleaned using sandblasting as preferred cleaning method were higher, followed by the bars cleaned by acid immersion and the uncleaned bars in terms of both weight loss and CT scanning measurements as shown in Fig. 8. This result along with the fact that the different bars were considered arbitrarily within the tested beams indicates that the accuracy of the rust removal was strongly dependent on the employed cleaning method.

relevant when higher corrosion levels were observed as shown in Fig. 9b, i.e. the more corroded the bar, the better the performance of the cleaning method. Nevertheless, the ratio of CT scanning to weight loss measurement did not correspond to values exceeding 0.9, which clearly showed a limitation of the accuracy of CT scanning. Furthermore, the corrosion level evaluation results of the uncleaned bars by using CT scanning technique revealed that the selected accuracy value was not sufficient to distinguish between the rust and steel, and consequently, it is necessary to carefully clean the bars prior to scanning.
